State of California — The Resources Agency
DEPARTMENT OF PARKS AND RECREATION
PRIMARY RECORD

Page 1 of 1 *Resource name(s) or number (assigned by recorder) 969 Natoma St.

BUILDING, STRUCTURE, AND OBJECT RECORD

Page 1 of 3 *NRHP Status Code 6Z
*Resource Name or # (Assigned by recorder) 969 Natoma Street

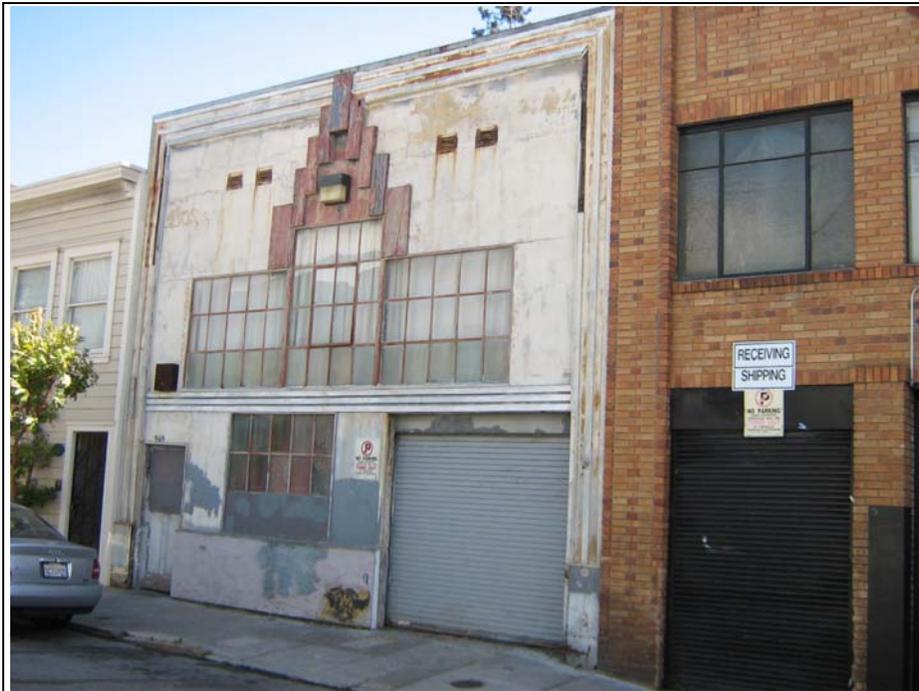
969 Natoma St. is located on a 25' x 75' lot on the south side of Natoma Street, between 10th and 11th Streets. Built in 1906, 969 Natoma Street is a 2 story, wood frame, industrial building altered to Art Deco style. The rectangular-plan building, clad in flush metal panels, is capped by a parapeted gable roof. The primary façade faces north and is 3 bays wide. The entire façade is outlined in a two-tier architrave molding created with applied wood strips. The first story features an entrance with wood door in the left bay, a fixed metal-frame, multi-pane window in the center bay, and a bay entrance with metal overhead door in the right bay. The second story has a contiguous window composed of two metal-frame, multi-pane fixed sash flanking a vertically-oriented metal, divided fixed sash with central awning sash. The window is capped by an oversized, stepped pyramidal wood cap that extends to the roof line. Two metal vents are located on either side of the window cap. The building appears to be in fair condition, with large areas of failing paint and rust. The window sash also shows deterioration.

*P5b. Photo: (view and date)
View from north
9/5/2006
