State of California — The Resources Agency
DEPARTMENT OF PARKS AND RECREATION
PRIMARY RECORD

Page 1 of 2 *Resource name(s) or number (assigned by recorder) 77-83 Colton St.

BUILDING, STRUCTURE, AND OBJECT RECORD

Page 1 of 2 *NRHP Status Code 6Z
*Resource Name or # (Assigned by recorder) 77-83 Colton Street

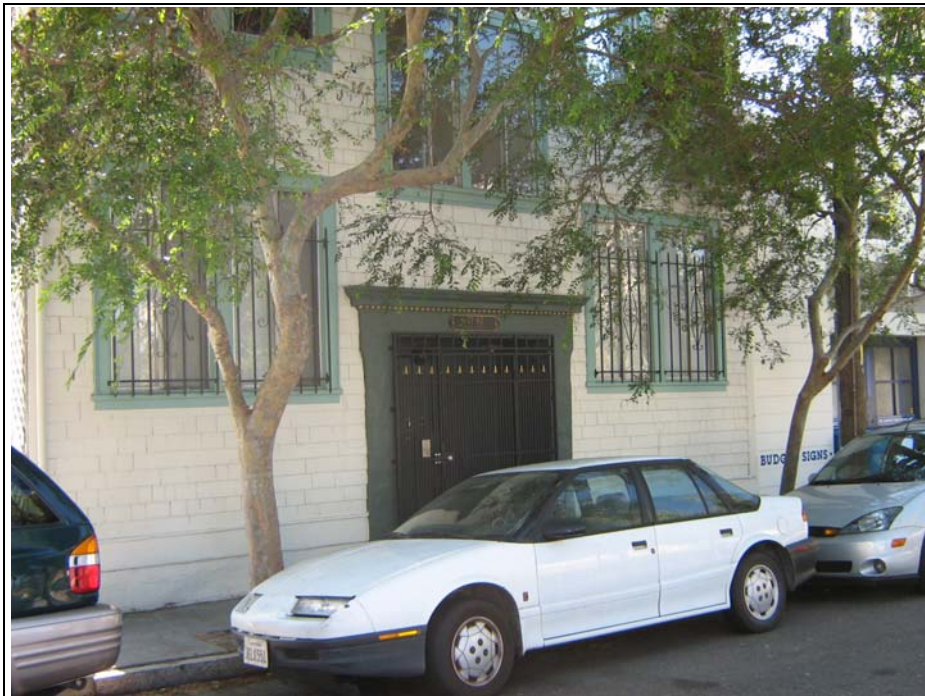
P5b. Photo: (view and date)
View from north
8/31/2006

77-83 Colton Street is located on a 28.5' x 60.5' lot on the southeast side of Colton Street between Colusa Place and Brady Street. Built in 1908, 77-83 Colton Street is a 2-story, wood-frame set of 4 enclosed Romeo flats originally designed in the Classical Revival style. The rectangular-plan building, clad in wood shingle, shiplap, T-111, and vinyl siding, sits on a concrete perimeter foundation and is capped by a flat roof. The primary façade faces north and is 3 bays wide. The central bay of the first floor features a gated recessed entry with a stucco surround and cornice with bead molding. The building has two entrances fitted with modern wood doors. The right and left bays feature barred sliding metal sash windows with architrave surrounds and unified sills. The second story has identical windows in the right bay, and two modern wood casement sash in the left bay. The center bay has a pair of metal, sliding sash windows above the entrance, set between the first and second story heights. The primary façade terminates in a modillion cornice. The side elevations are clad in shiplap and T-111 siding and have light wells with variously-sized metal sliding sash windows. The rear elevation is clad in vinyl siding and has metal sliding sash windows and a square picture window in the left bay of the second story. Four metal vent pipes protrude above the roof at the rear of the building. The building appears to be in good condition.

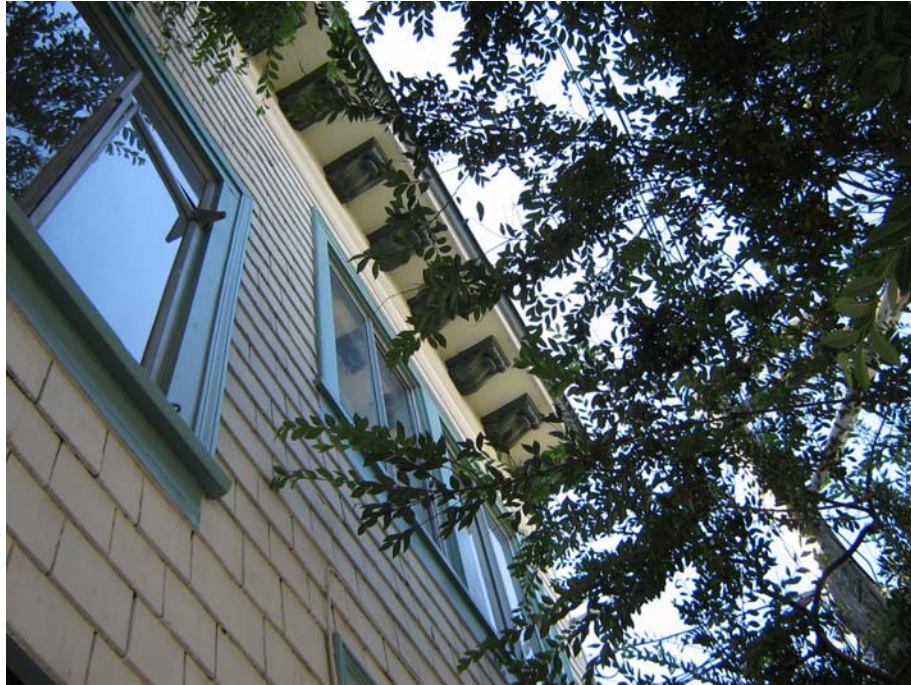
Detail, upper story and roofline

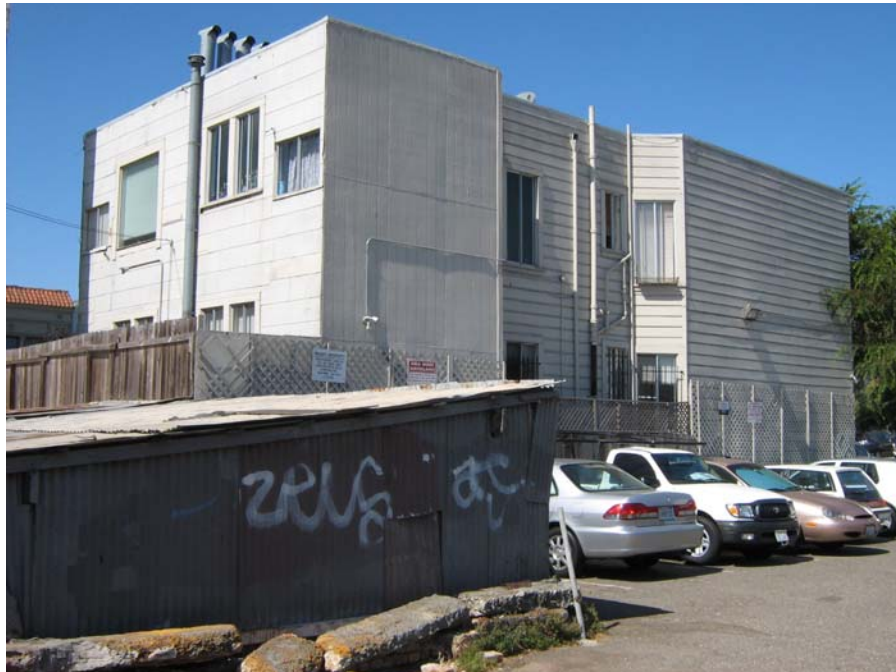
View of rear (northeast) and northwest elevations

77-83 Colton Street has undergone alterations including the removal of original windows and the replacement with contemporary aluminum sash sliding windows, the removal or covering of the original cladding at the primary facade and recladding in wood shingle, the recladding of areas of the secondary facades in T-111 and vinyl siding, and the removal of original doors and replacement with contemporary doors. Additionally, the area around the building has changed significantly, and the building is surrounded by large parking lots on three sides. The building retains integrity of location, and partially retains integrity of association, feeling, materials, workmanship and design. The building does not retain integrity of setting.
