State of California — The Resources Agency
DEPARTMENT OF PARKS AND RECREATION
PRIMARY RECORD

Page 1 of 1 *Resource name(s) or number (assigned by recorder) 53-55 Landers St.

BUILDING, STRUCTURE, AND OBJECT RECORD

Page 1 of 3 *Resource Name or # (Assigned by recorder) 53-55 Landers Street

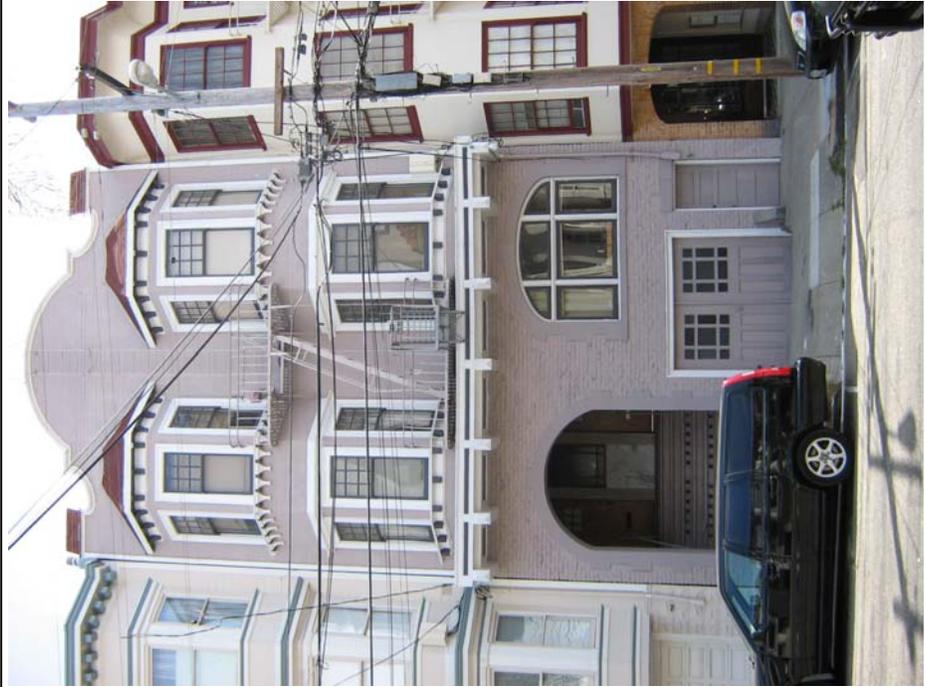
P5a. Photo

*P3a. Description: (Describe resource and its major elements. Include design, materials, condition, alterations, size, setting, and boundaries.)
53-55 Landers St. is located on a 25' x 125' lot on the east side of Landers Street, between 14th and 15th Streets. Built in 1909, 53-55 Landers St. is a 4-story, wood frame, 5 unit, multiple family residential building designed in the Mission Revival style. The rectangular-plan building, clad in flush wood siding and brick veneer, is capped by a flat roof. The primary façade faces west and is 2 bays wide. The first level, clad in painted brick, features an integral garage and secondary entrance in the right bay and an arched entry with recessed stairway in the left bay. The second floor, also clad in painted brick, features a recessed entry porch in the left bay and an elliptical arched casement and center fixed-sash windows in the right bay. The recessed entry includes a marble base, wood paneling, and two glazed wood doors. The second floor is capped by a projecting intermediate cornice with oversized jette. The upper two floors are clad in flush wood siding and are characterized by bay windows with double-hung, wood sash. The windows at the third floor have rafter tails at the sill. The windows at the fourth floor have corbelled sills and hipped roofs with rafter tails at the cornice. The primary façade terminates in a shaped false parapet with coping. The building appears to be in good condition.

P5b. Photo: (view and date)
View from west
8/24/2006
