State of California — The Resources Agency
DEPARTMENT OF PARKS AND RECREATION
PRIMARY RECORD

Page 1 of 2 *Resource name(s) or number (assigned by recorder) 177 Valencia St.

BUILDING, STRUCTURE, AND OBJECT RECORD

Page 1 of 2 *Resource Name or # (Assigned by recorder) 177 Valencia Street

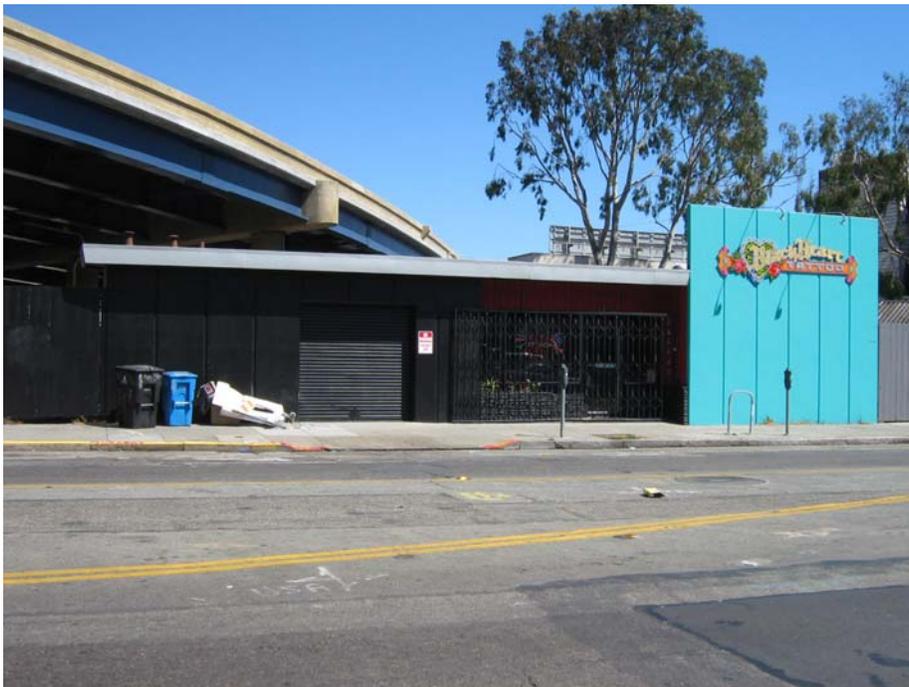
177 Valencia St. is located on a triangular 66' x 80' x 115' lot on the east side of Valencia Street, between Mc Coppin Street and Duboce Avenue. Built in 1959, 177 Valencia St. is a 1-story, reinforced concrete commercial building designed in the Modern style. The triangular-plan building, clad in board and batten wood siding, sits on a reinforced concrete, slab foundation and is capped by a flat roof. The primary façade faces west and is 3 bays wide. The wall and roofline at the north (left) end of the façade extends beyond the plane of the north elevation. The facade features a garage in the left bay and a recessed storefront in the center bay with formstone planters. The storefront has metal-frame plate glass windows and a single metal-frame, glazed commercial door. The roof has a deep eave overhang sheltering the garage and storefront. At the right bay of the façade, the board and batten wall is flush with the roofline and extends above the roofline in a tall parapet. The parapet wraps around the south elevation of the building. The building appears to be in good condition.

P5b. Photo: (view and date)
View from west
8/30/2006

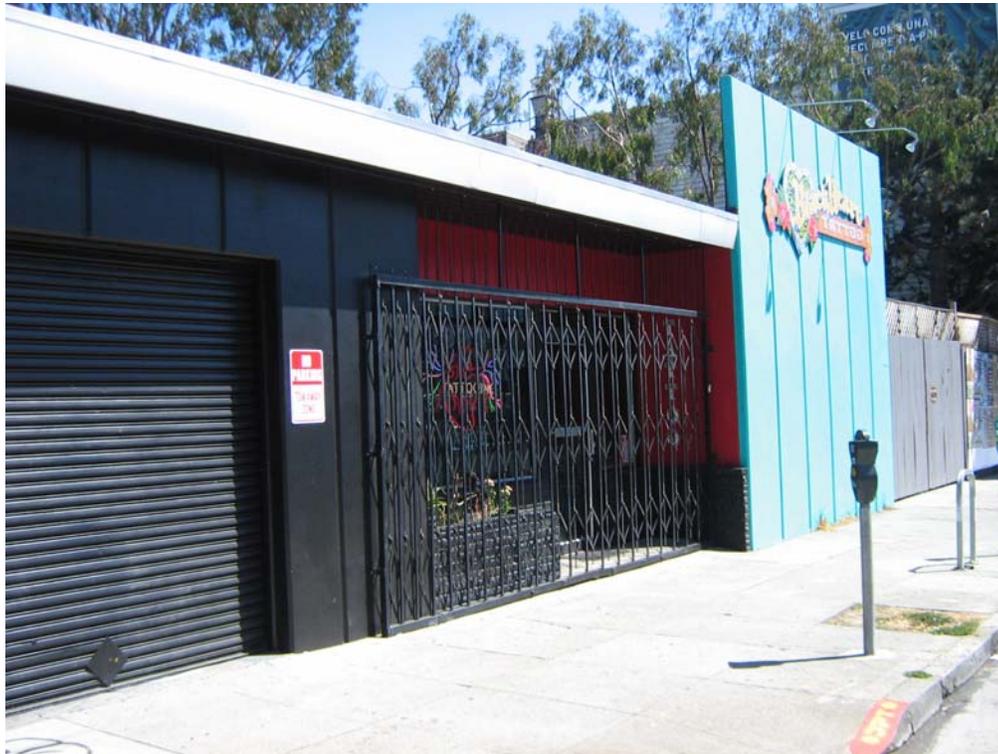
Detail, storefront and parapet wall

177 Valencia Street is a utilitarian commercial building with limited features that recall the International Style, including its horizontal massing and proportions, flush fenestration, and arrangement of vertical and horizontal planes that intersect each other, particularly the tower element on its south side. There is no architect of record for the building and it is likely that its modern styling is more a function of utility and inexpensive construction than deliberate design.

177 Valencia Street appears to have undergone few if any exterior alterations and retains the majority of its character defining features. Alterations include the possible replacement of original window frames and doors with contemporary anodized aluminum sash windows. Otherwise, the building retains all of its character defining features, including its one story height and triangular plan, asymmetrical facade, industrial roll-up garage door, recessed and fully glazed storefront, formstone planters, deep boxed eave overhang, and asymmetrical parapet. The building retains the following aspects of integrity: association, feeling, workmanship, design, materials, location, and setting.
