State of California — The Resources Agency
DEPARTMENT OF PARKS AND RECREATION

PRIMARY RECORD

Page 1 of 1 *Resource name(s) or number (assigned by recorder) 559 Fell St.

*c. Address: 559 Fell St. City: San Francisco Zip: 94102

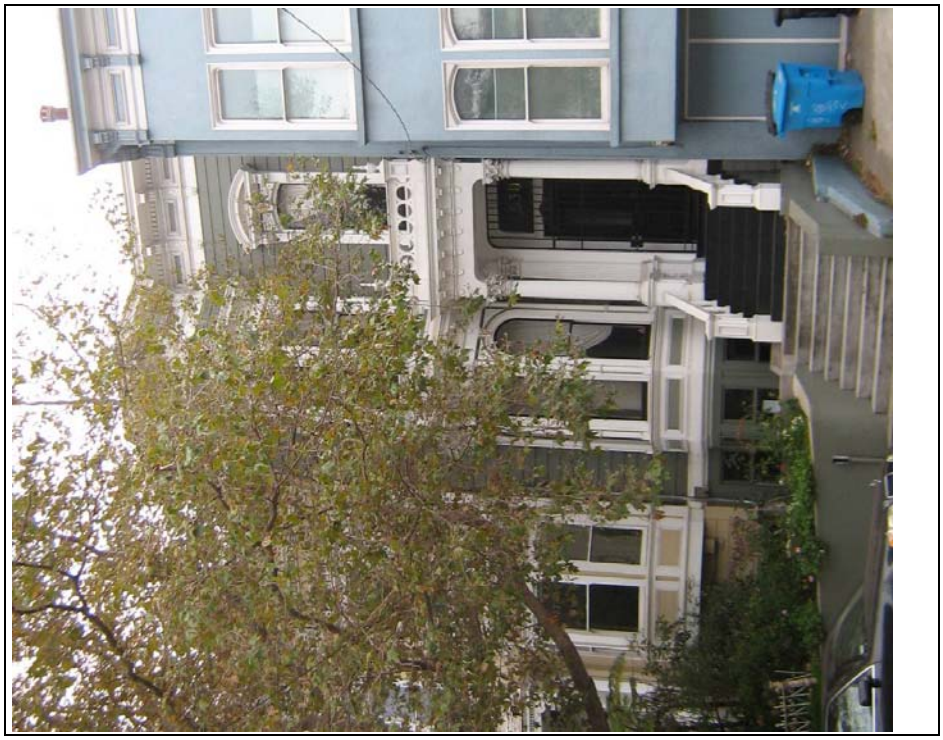
P5b. Photo: (view and date)
View from north
10/30/2006

559 Fell St. is located on a 22' x 120' lot on the south side of Fell Street that runs the width of the block and continues to Hickory Street between Laguna and Buchanan Streets. Built in 1910, 559 Fell St is a 2-story, wood frame, single family dwelling designed in the Italianate style. The rectangular-plan building, clad in drop wood siding, is capped by a false-front gable roof. The primary façade faces north and is 2 bays wide. The building is set back from the street and the frontage is enclosed with a concrete retaining wall. A set of concrete steps is set at the right end of the lot frontage. The raised basement story features a bay window with double-hung, wood sash in the left bay. The right bay features a set of wood steps with turned balustrade accessing the main entrance on the first story. The main entrance is sheltered by a recessed entry porch with a portico composed of Corinthian columns and pilasters and an entablature hood with bracketed cornice and roof balustrade. The building has a single entrance fitted with a paneled, glazed wood door with arched transom. The left bay contains a semi-hexagonal bay window with arched, double-hung wood sash, spandrel panels, Corinthian colonnette surrounds, and bracketed cornice. The second story has an identical bay window in the left bay and a single flush window in the right bay with a segmental arched, double-hung wood sash, and a bracketed, round pediment hood. The primary facade terminates in a paneled frieze and a bracketed cornice with dentils. The rear façade has been altered. It is clad in wood shingle siding (continued)
