# What are we dealing with?

The Yosemite Slough Neighborhood Adaptation Plan builds upon decades of climate resilience work in Bayview Hunters Point. In partnership with the community, there are numerous efforts to protect the neighborhood from flooding and increase public benefits. Here are some snapshots of these efforts.

## **UPPER YOSEMITE CREEK DAYLIGHTING PROJECT**

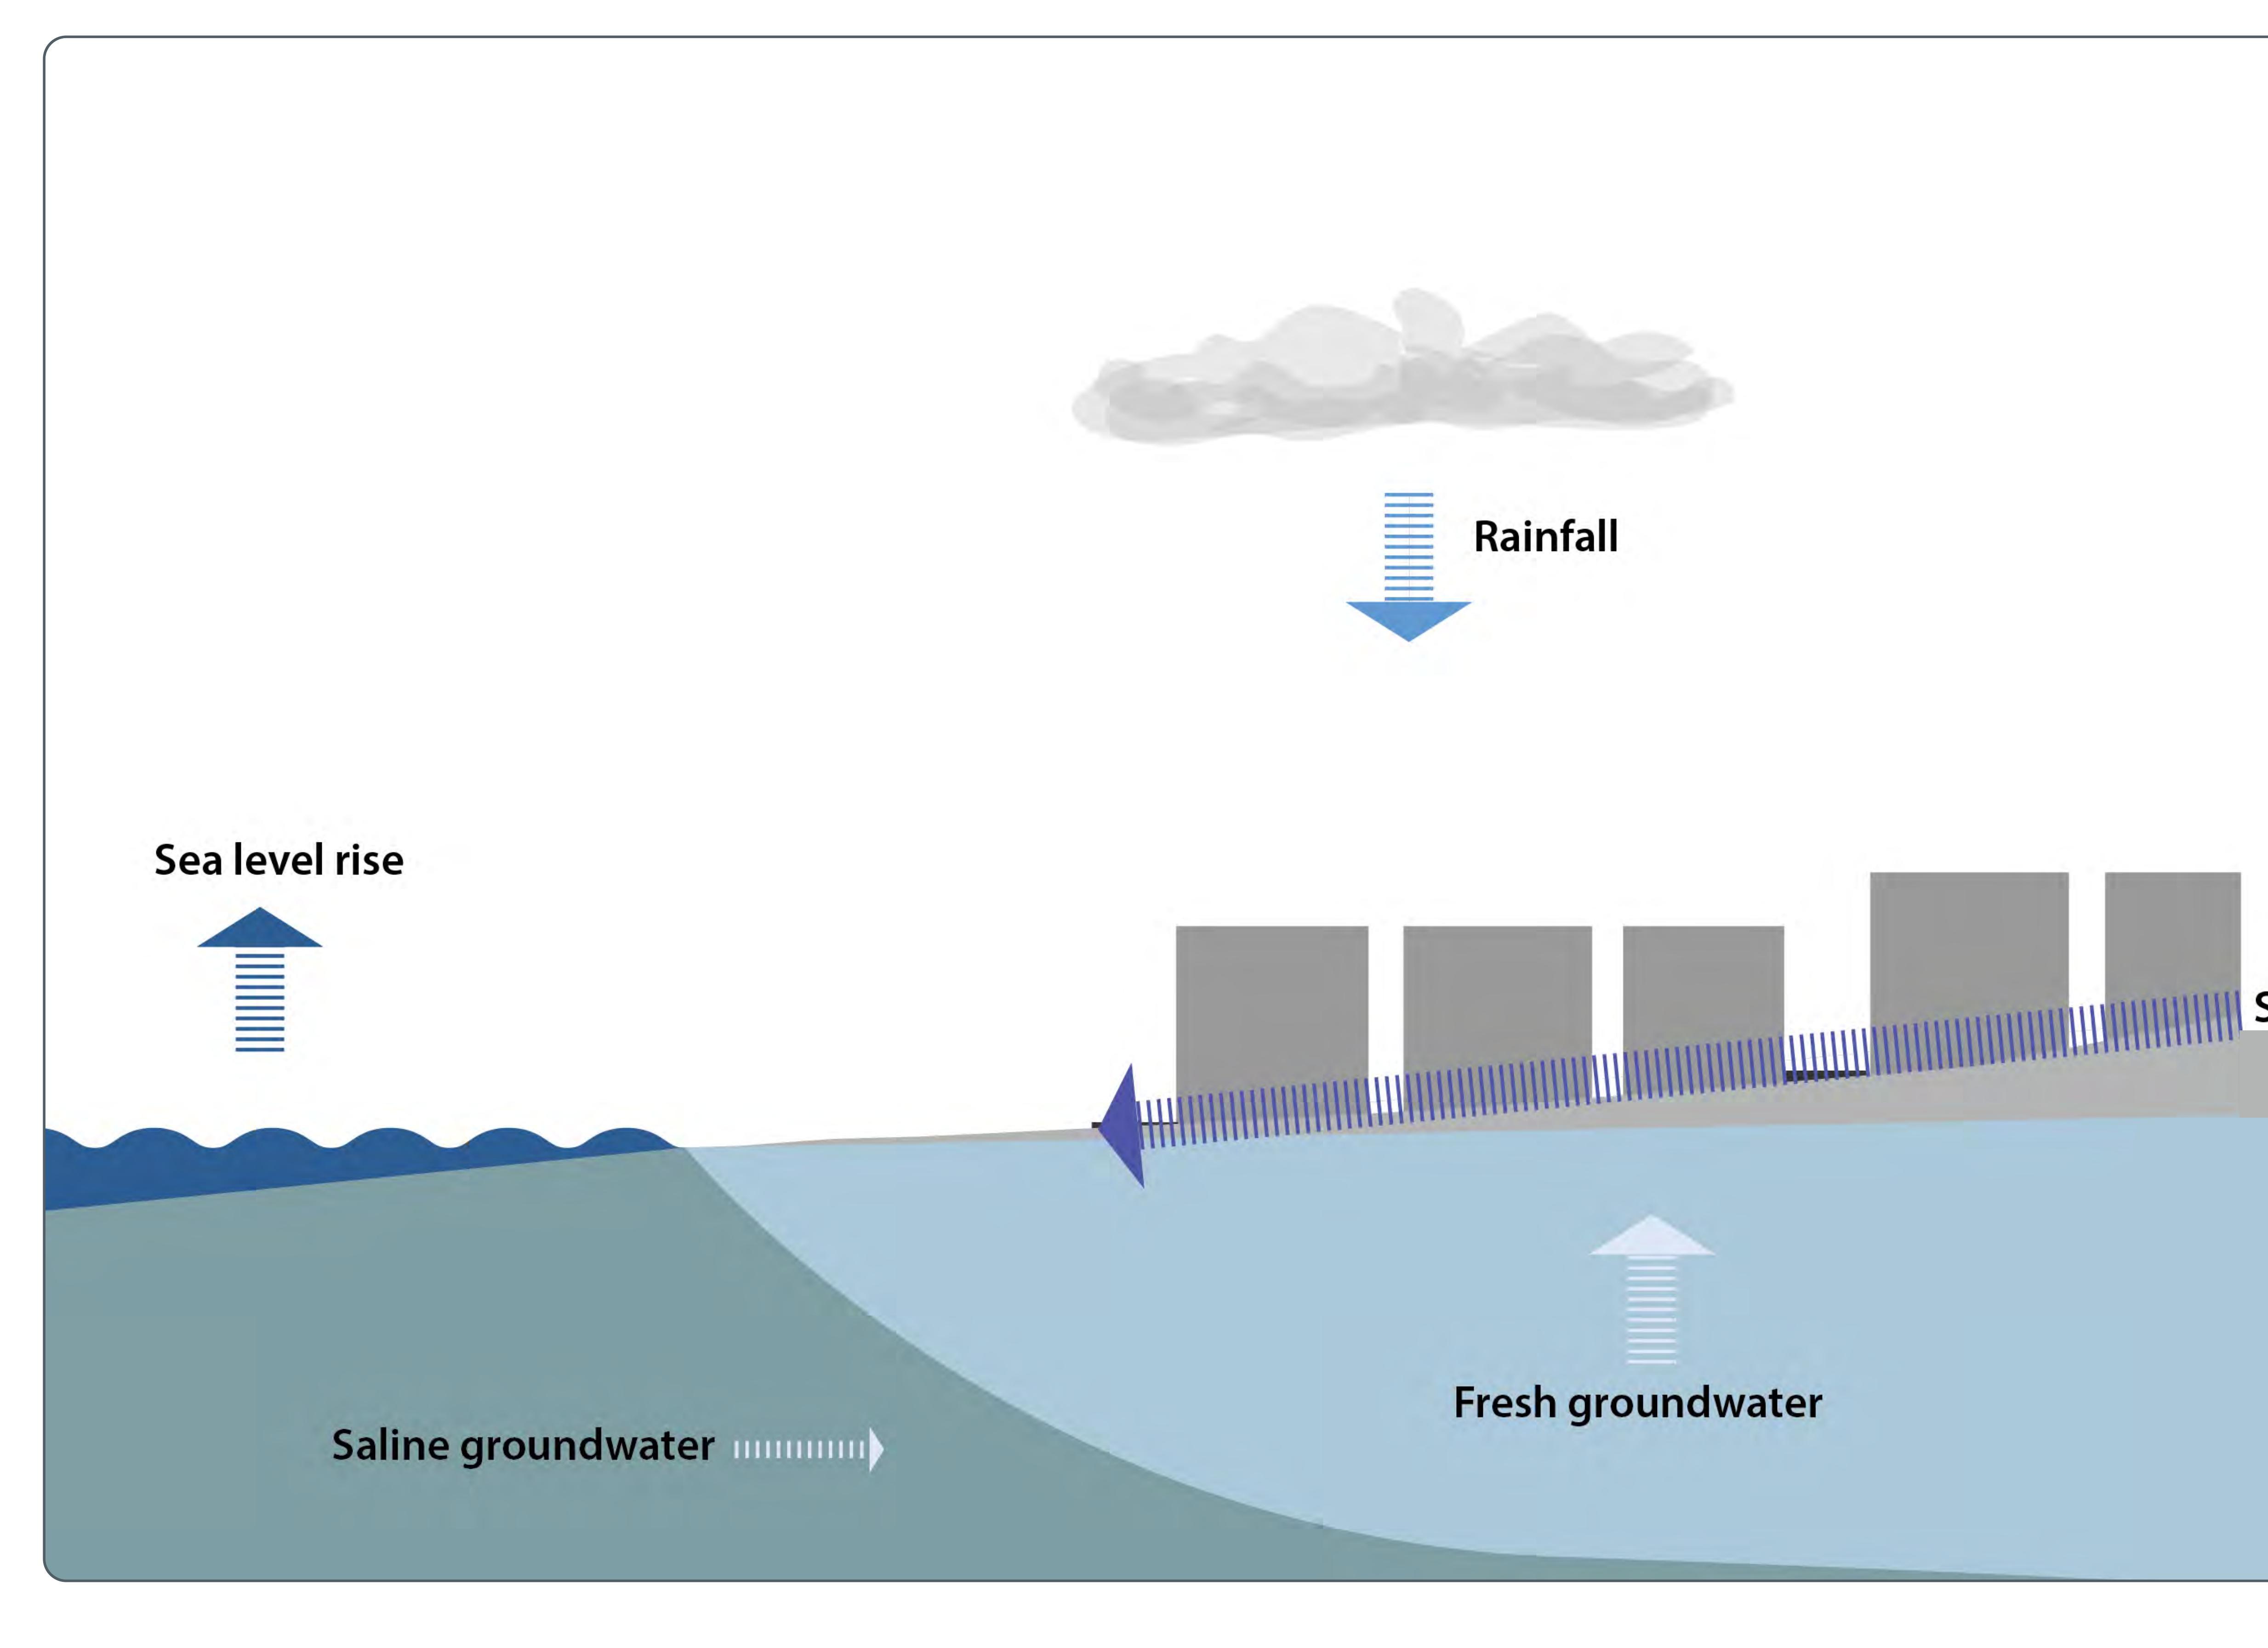
The Yosemite Slough is a low-lying area built on porous landfill this makes the neighborhood more vulnerable to sea level rise, emergent groundwater, and stormwater flooding.

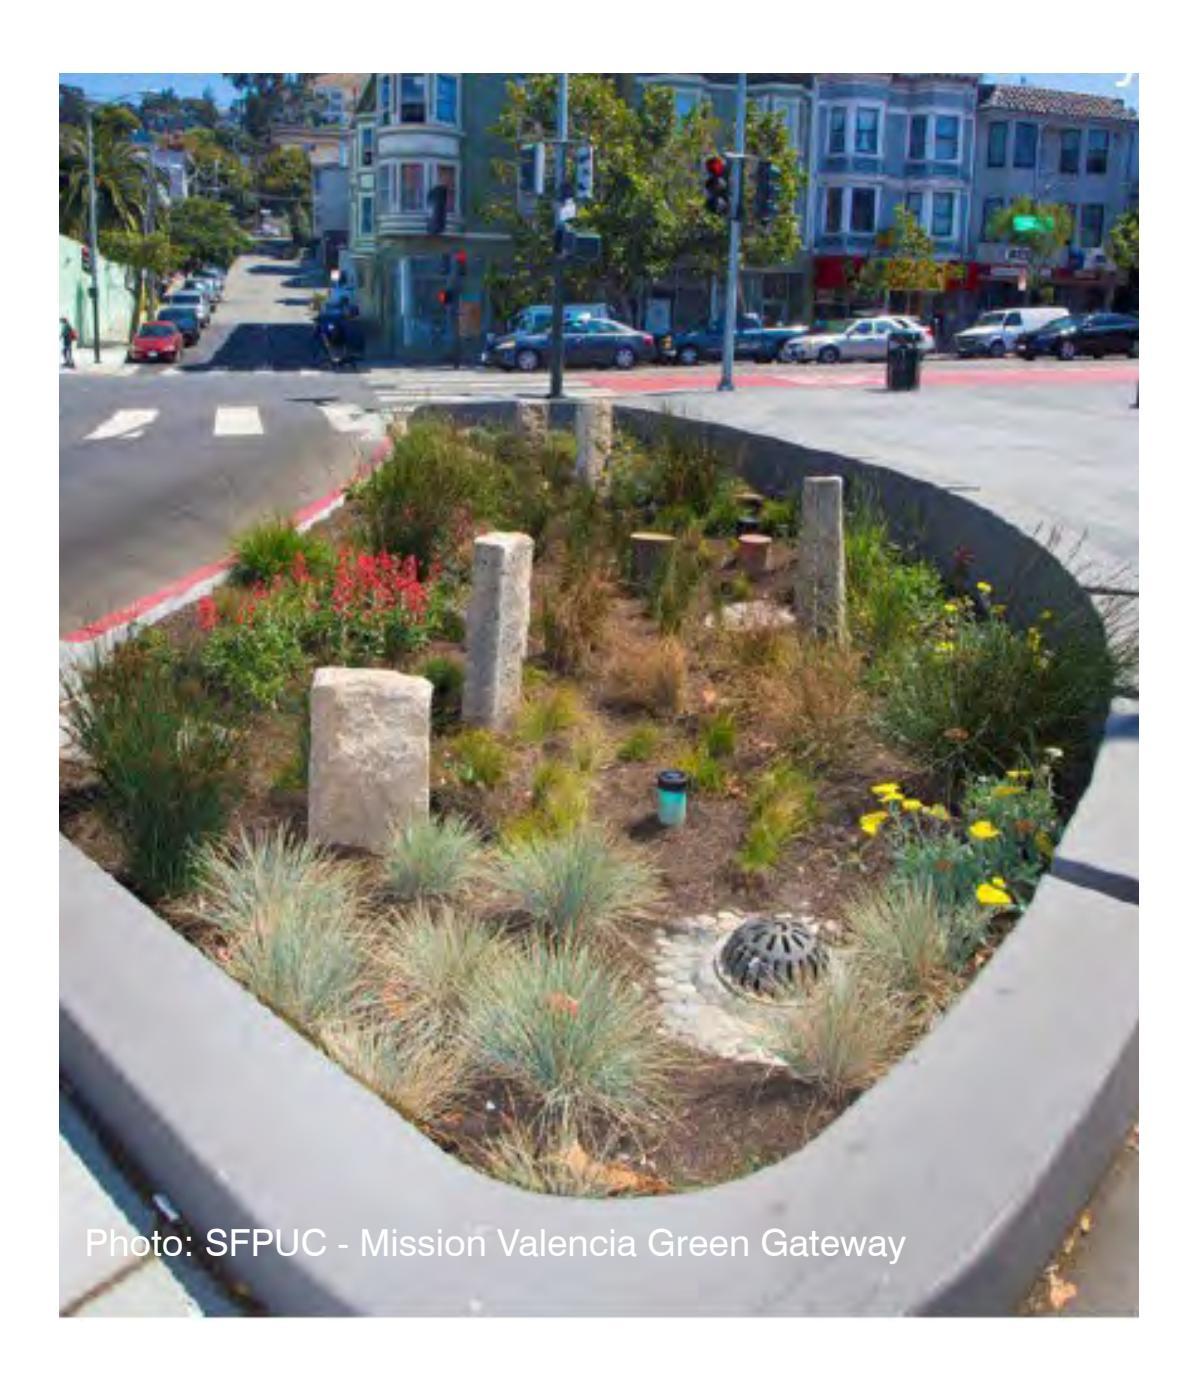
The SFPUC is daylighting the upper-most portion of Yosemite Creek, which once flowed from McLaren Park near McNab Lake all the way to the San Francisco Bay. The daylighting of this historic Yosemite Creek will mitigate excess stormwater that currently flows along Oxford Street. The project will use innovative green infrastructure to reduce flows into the combined sewer system.
